# GODDARD SPACE FLIGHT CENTER

## Evaluation Report

Microcircuit (10)  
Mfr.: MICREL  
P/N: SY89424VZC  
D/C: 9910

Project  
VCL  
System  
Parts testing  
Requester  
K.Sahu (562)  
Initiated Date  
10/01/00  
Investigator  
A.Teverovsky (562)

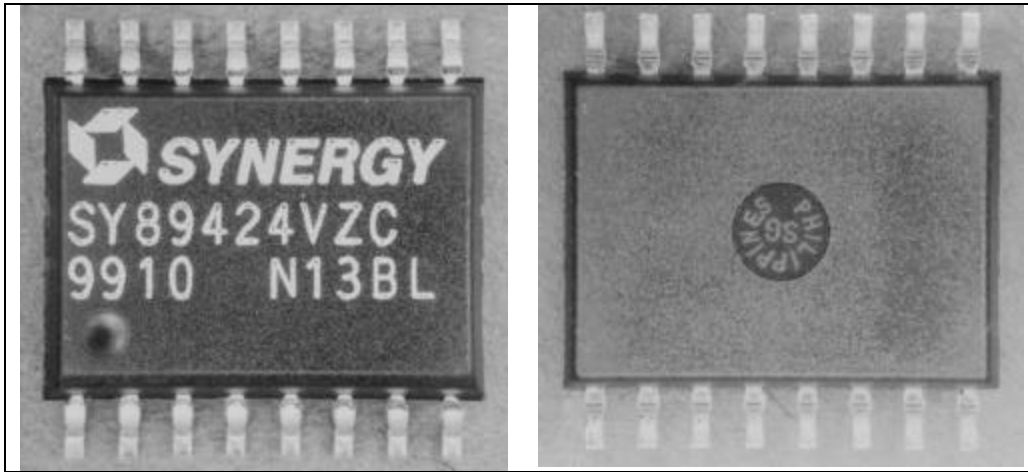
External examination showed that the part had no package warping, cracks, voids, or foreign inclusions in the plastic encapsulant. One sample had a minor chip-out at the package edge, however, this defect can be considered as minor. No gaps were observed between the entry of the leads and the molding compound (MC). Figure 1 gives external views of the part.

Figure 1. Top and bottom views of the part.

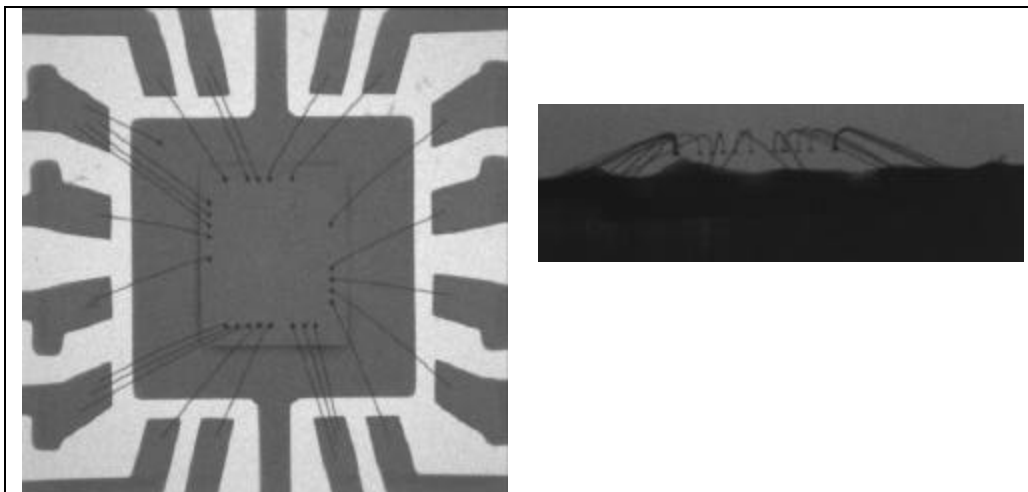
Radiographic examination showed adequate wire bond dressing. Typical top and side X-ray views of the part are displayed in Figure 2.

Figure 2. Typical top and side radiographic views of the part showing adequate lead frame design, wire dressing and layout.

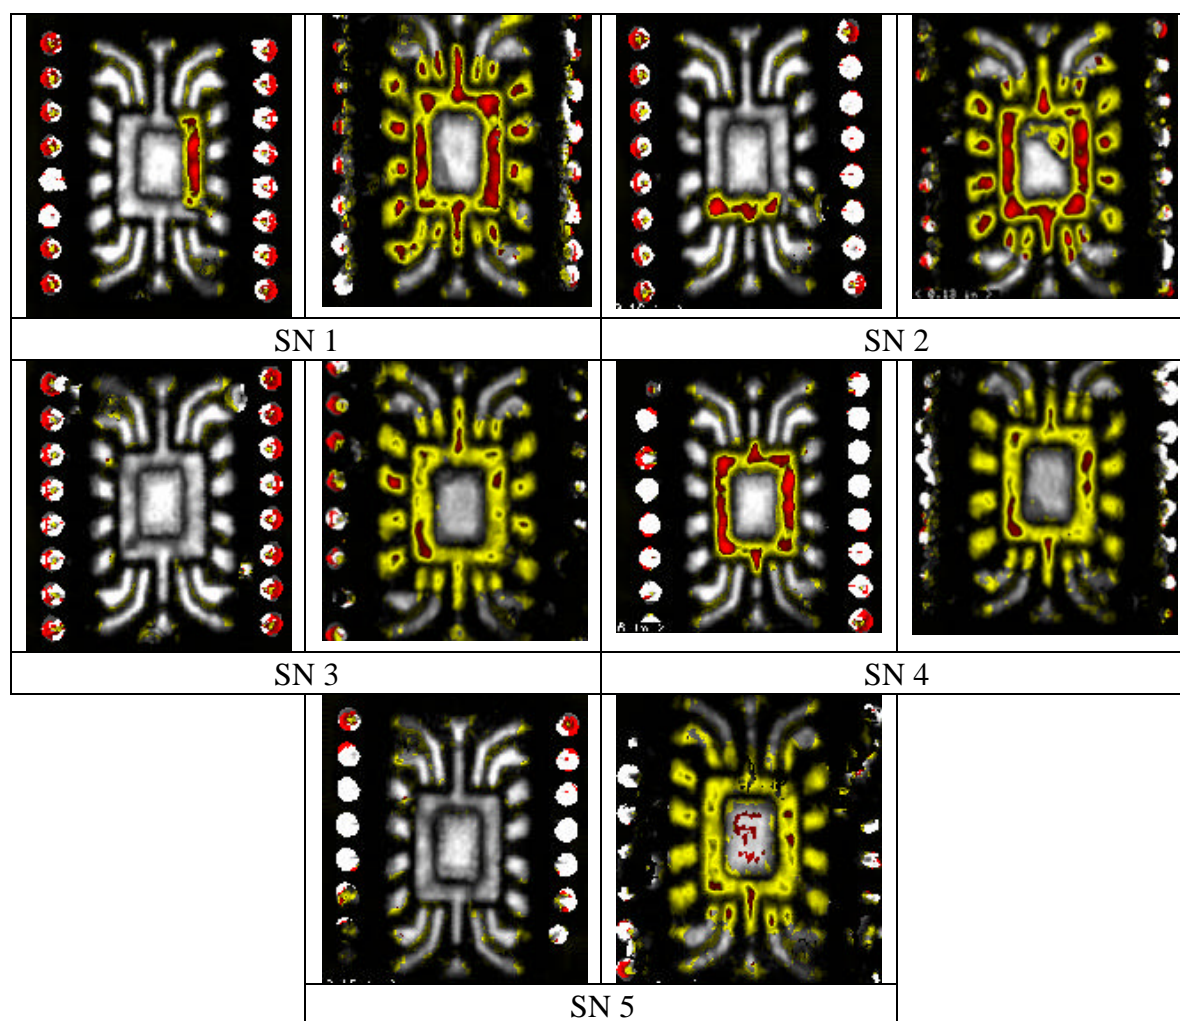
Initial C-SAM examination showed (see Figures 3 and 4) that three out of five parts had partial delamination at the paddle-molding compound interface. External visual examination after solder pot simulation did not reveal any defects. However, acoustic microscopy showed that after the test all parts had entire paddle area delaminated and, what is more important, in one part, SN 2, an interfacial gap had been formed on the die surface. Also, three parts (SNs 1, 2, 3) had delaminations at the lead tips, where the wires are crescent bonded to the lead frame.

Figure 3. MICREL SY89424VZC acoustic images before (left) and after (right) solder pot test. Top side.  
( $f = 15$  MHz,  $Z = 21.5$  us, pos. 0.489, wind. 0.4)

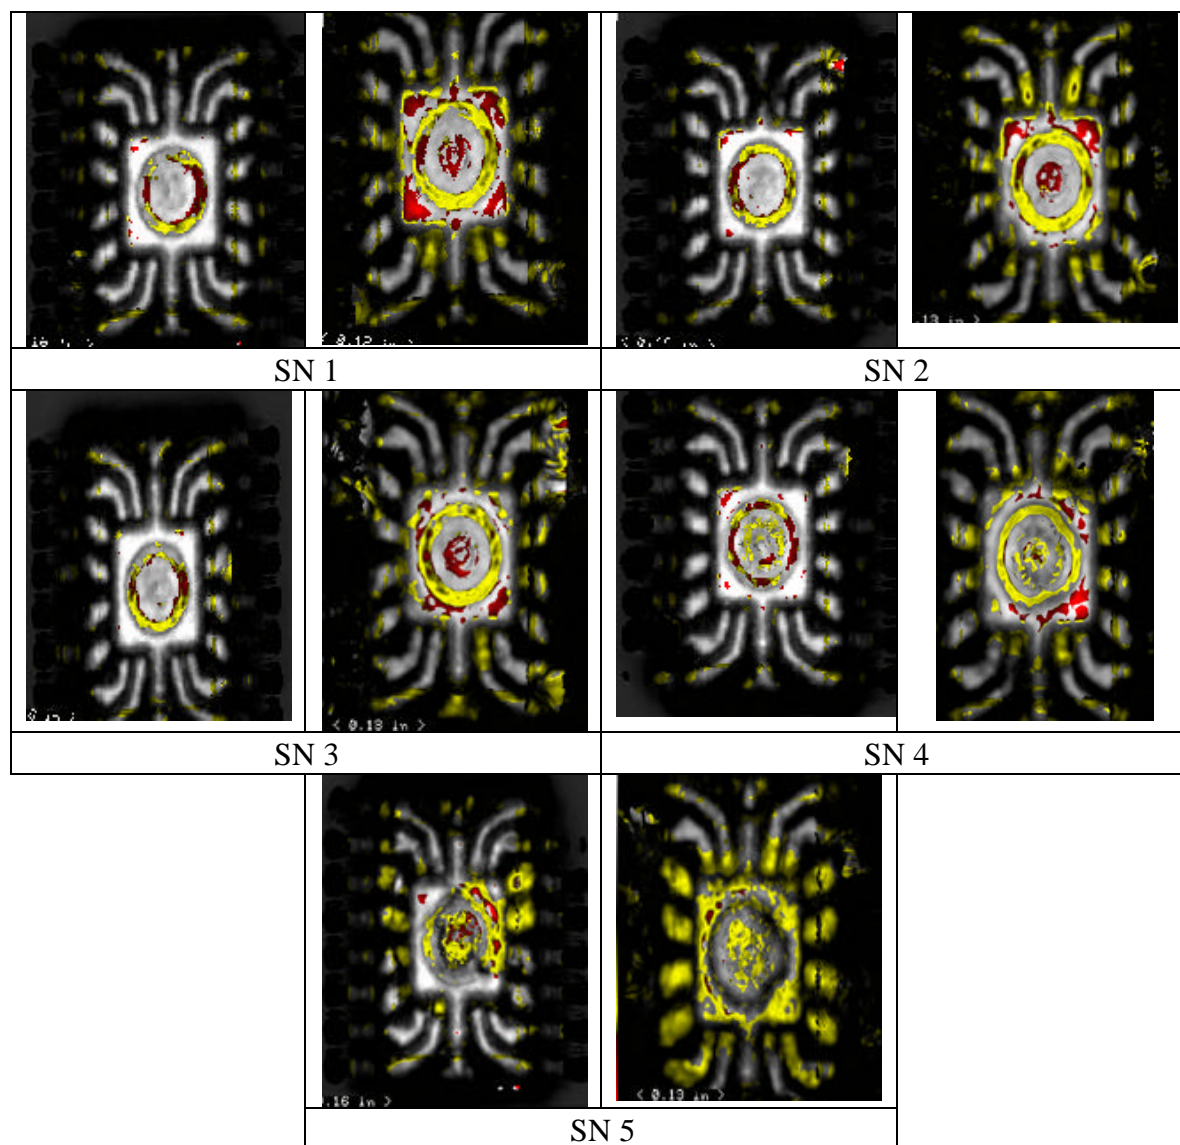
Acoustic inspection of the bottom side also revealed an increase of delaminated area at the paddle back side-molding compound interface (see Figure 4).

Figure 4. MICREL SY89424V acoustic images before (left) and after (right) solder pot test.  
Bottom side. ( $f = 15$  MHz,  $Z = 21.1$  us, pos. 0.431, wind. 0.3)

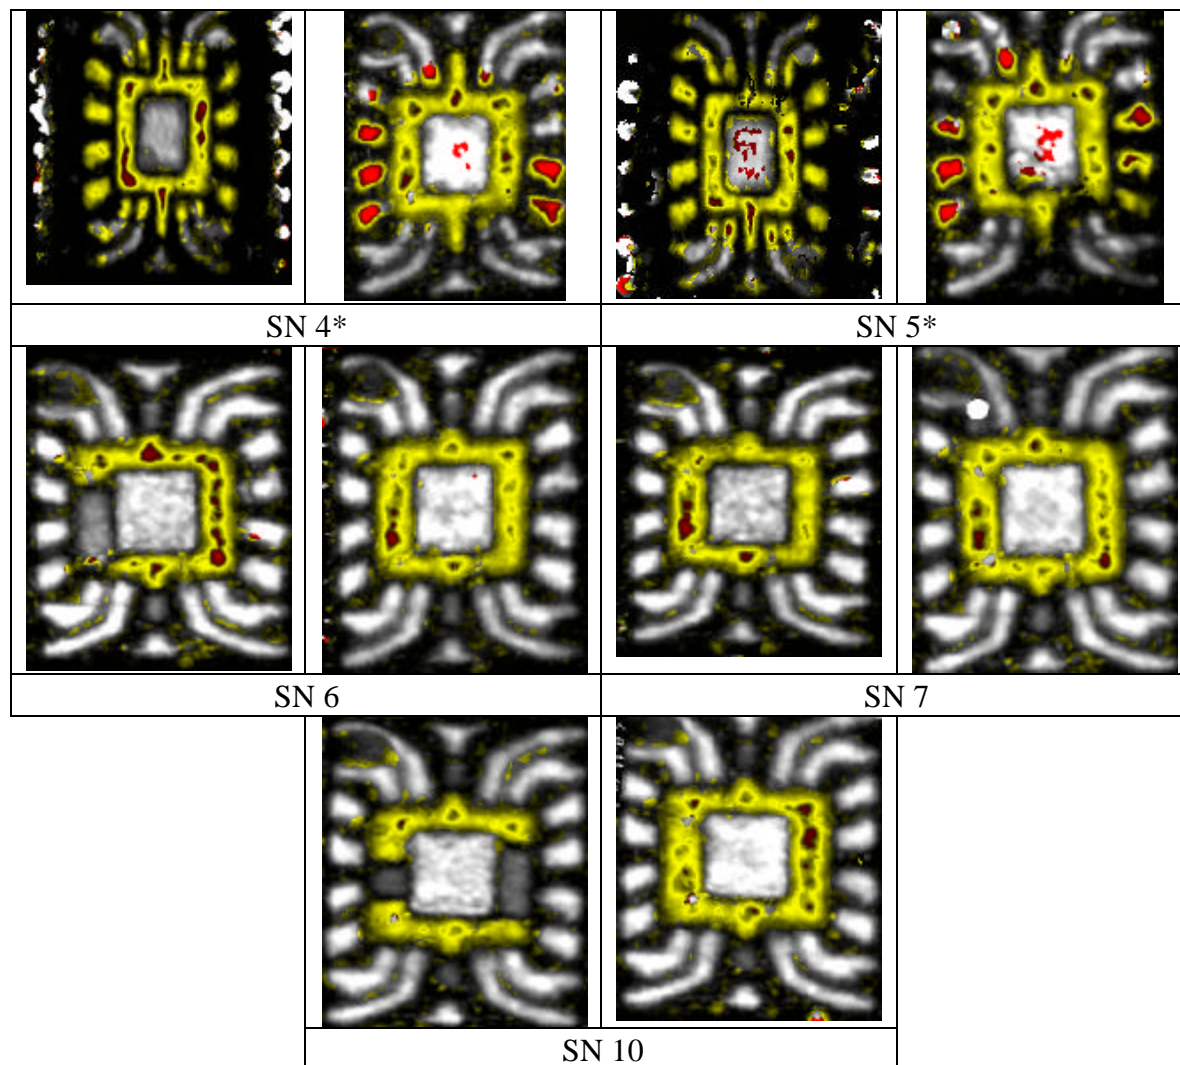
In the new parts delamination at the top-side paddle-MC interface was increased to 100% of the available area. However, no defects were observed on the die surface and on the lead tips. Two previously stressed parts (SN 4 and 5) had an increased area of delamination at the lead tips.

Figure 5. Acoustic images before (left) and after (right) 100 temperature cycles between  $-65^{\circ}\text{C}$  and  $+150^{\circ}\text{C}$ . Top side. Samples 4 and 5 were subjected to the solder pot test before temperature cycling.

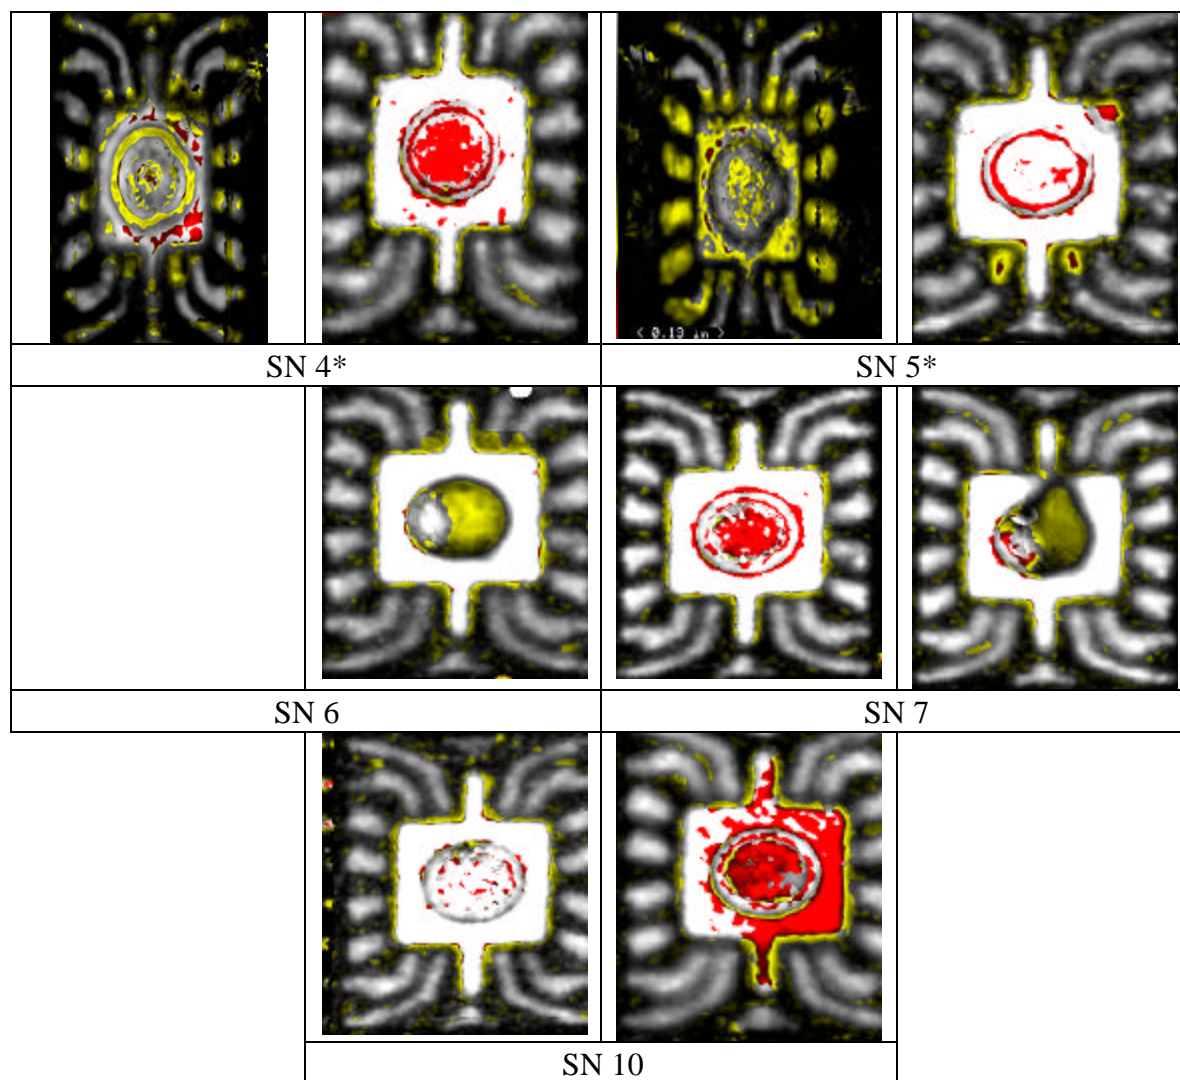
Temperature cycling resulted in an increase of delaminated area at the paddle back side in only one part, SN 10.

Figure 6. Acoustic images before (left) and after (right) 100 temperature cycles between  $-65^{\circ}\text{C}$  and  $+150^{\circ}\text{C}$ . Bottom side. Samples 4 and 5 were subjected to the solder pot test before temperature cycling.

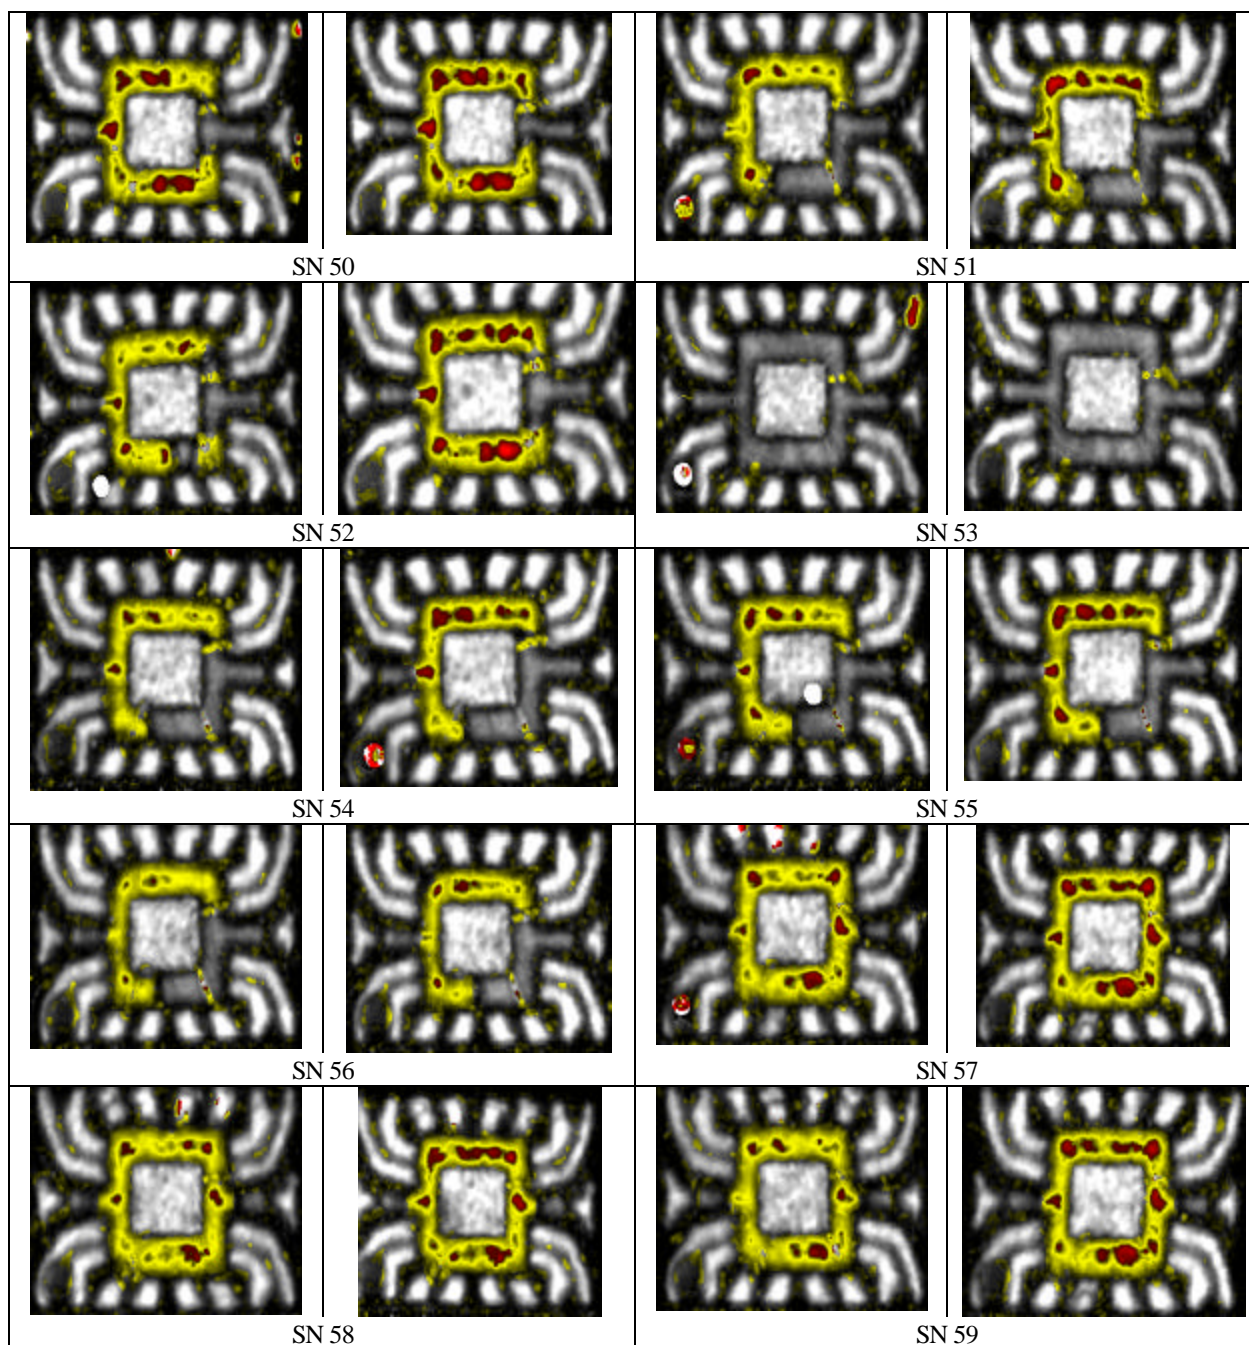
1. All parts except SN 53 exhibited delamination of different degree at the top-side of the paddle-molding compound interface.
2. None of the parts had delamination at the critical locations (die surface and lead frame tips) neither before nor after temperature cycling.
3. Anomalies observed on most of the parts at pins 6 and 9 were caused by triple wire bonding at these pins and were not most likely due to voiding.
4. Temperature cycling resulted in some increase in delaminated area in all parts (except SN 53 where no delamination was observed). In all cases except for SN 52 these changes can be considered as minor.
5. The best part for future applications is SN 53. All other parts, except for SN 52, were similar and demonstrated adequate stability at normal temperature cycling conditions.

Figure 7. Acoustic images before (left) and after (right) 20 TC  $-20^{\circ}\text{C}$  to  $+85^{\circ}\text{C}$ . Top views. Pin 1 is at the left bottom corner.

To ensure adequate quality of the parts for space applications, electrical testing of the lot at temperature extremes is recommended.

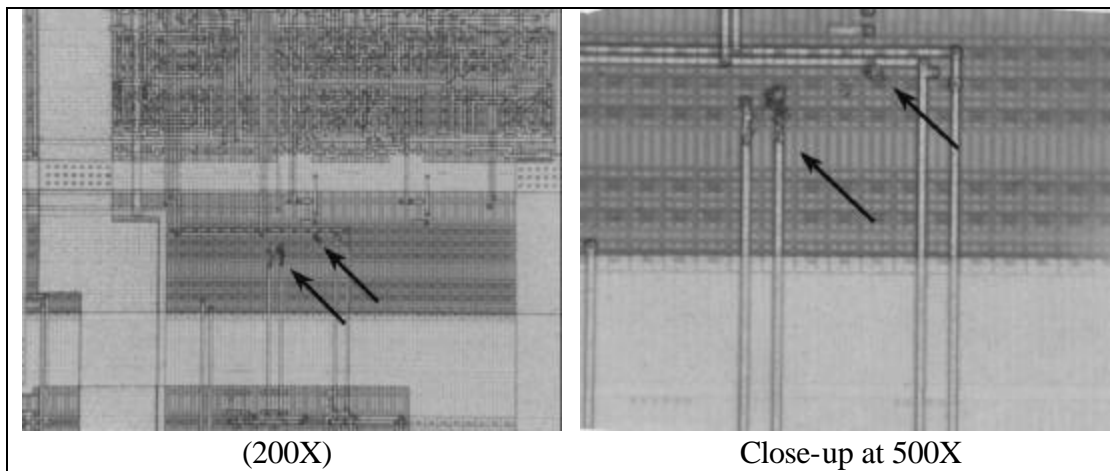
Two samples were decapsulated in red fuming nitric acid and examined under lower and high power optical microscope. Figure 8 shows overall view of the part after decapsulation and Figure 9 shows marking on the die. One of the dice had a mechanical damage on the surface (see Figure 10) which is rejectable per MIL-STD-883, TM2010.

Figure 10. Mechanical damage on the die surface which prohibit inspection of the underlying metallization and thus is rejectable per MIL-STD-883, TM 2010.

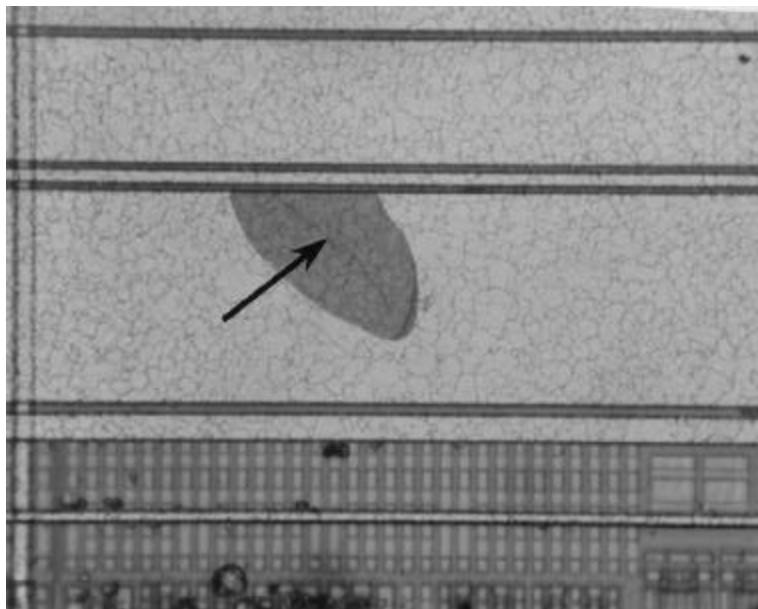
This examination was performed on one sample per MIL-STD-883D, Method 2021, "Glassivation layer integrity". The test involved a high-power optical examination after the die was subjected to aluminum etch. Aluminum etching revealed one crack in the glassivation (see Figure 11). However, detailed SEM examination of the glassivation in another part did not reveal any defects. Figure 12 shows typical SEM view of the glassivation.

Figure 11. A crack in the glassivation revealed during the glassivation integrity test. (500X)

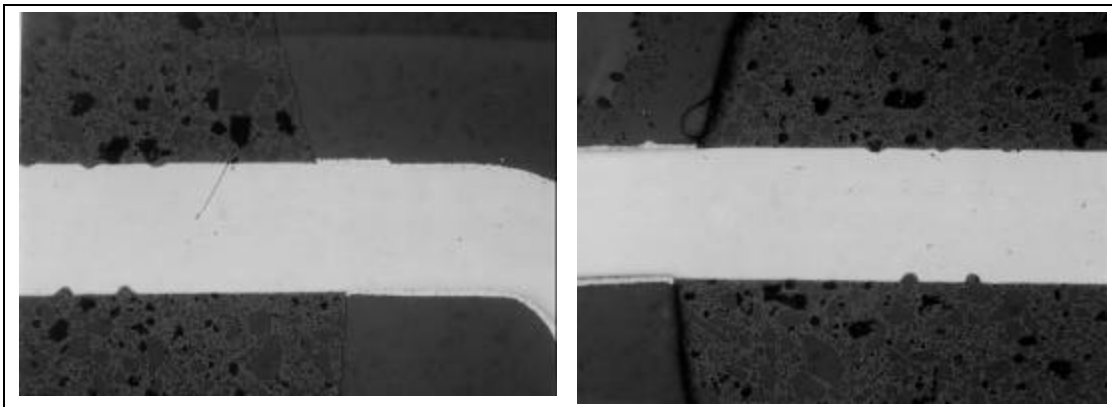
The molding compound had no internal cracks or voids and formed intimate contacts to all internal surfaces (die, wires, and lead frame). No delaminations between the glassivation and the molding compound were observed.

Figure 17. Close-up of the lead entries. (100X).

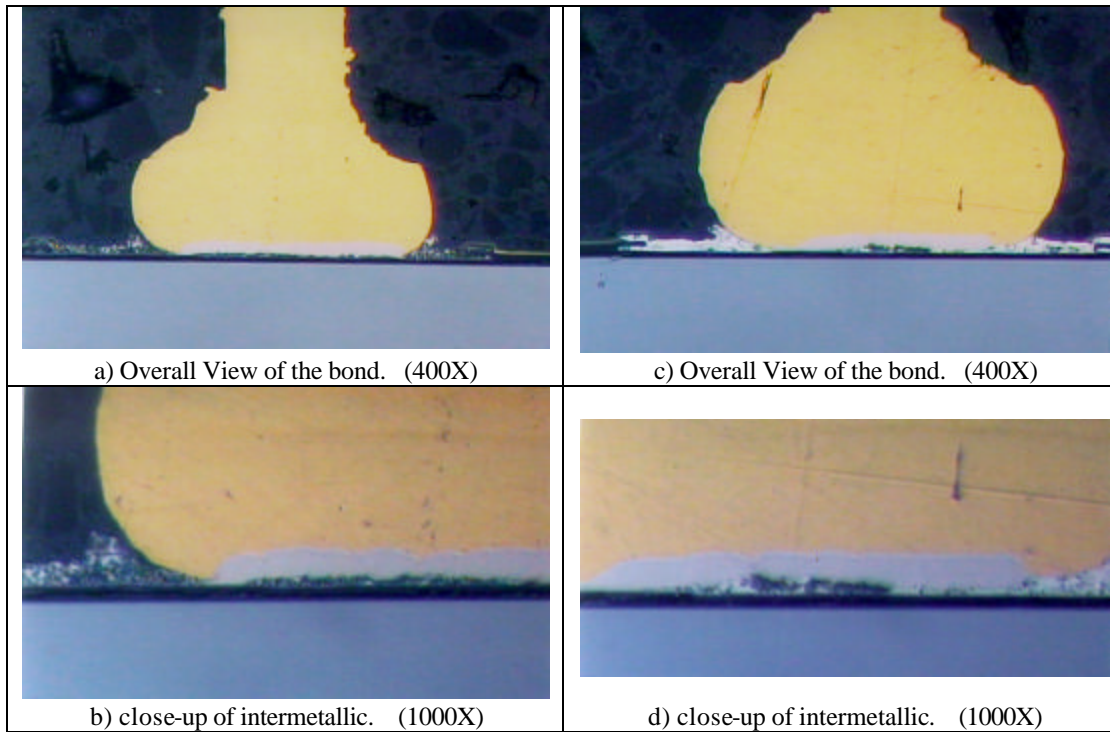
The die was mounted to the lead frame base with a thin layer of silver epoxy. The adhesive and silver filler were uniformly distributed along the die-paddle interface. Ball bond cross sectioning showed the formation of an adequate Au/Al intermetallic layer of 2 - 3  $\mu\text{m}$  in thickness (see Figure 18).

Figure 18. Cross-section of two wire bonds showing adequate Au/Al intermetallic formation.
